Appoquinimink Watershed Implementation Plan

Final Report
4/11/05

Prepared by
Center for Watershed Protection
8390 Main St, 2nd Floor
Ellicott City, MD 21043

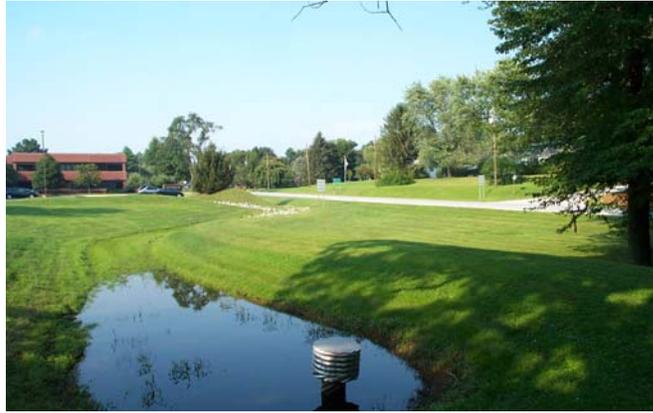
Figure 3. Existing stormwater pond at Odessa Professional Park

The Odessa Professional Park is located between north and south bound DE-13 south of Odessa and features an existing extended detention pond that captures over 9 acres of drainage (more than 3 acres of impervious cover). ARA should approach New Castle County and DelDOT regarding funding for a retrofit project to convert the existing facility (Figure 3) to a wetpond for water quality treatment, to capture runoff from DE-13, and to prevent erosion in roadside swales.

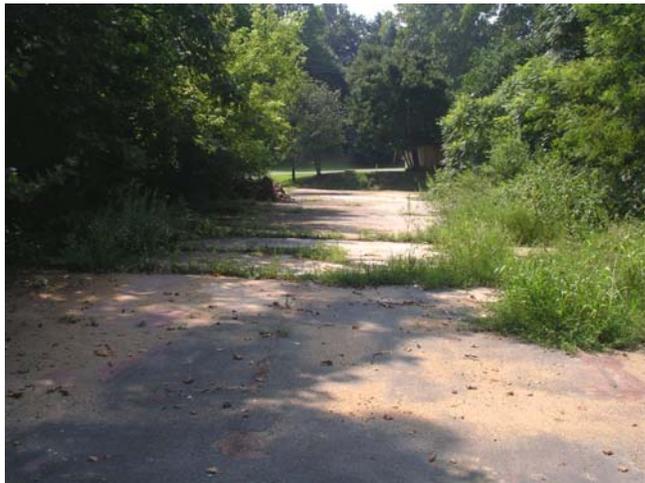
Figure 4. State property adjacent to Appoquinimink River in Odessa

This half-acre paved parcel adjacent to the Appoquinimink River in Odessa is across from the boat ramp on Route 299 (Figure 4), which is currently the only public boat ramp to the Appoquinimink River. ARA should work with DNREC and the local historic society to redevelop this state-owned parcel of land as an attractive and educational recreation space. Consider posting informative signage describing the historic attributes of the site as well as features of the Appoquinimink watershed. Restoration options could include rain gardens, reforestation, bufferscapes, or other demonstration projects. This project would help meet PCS goals to educate watershed residents and implement stormwater retrofits and may meet community historic preservation goals.

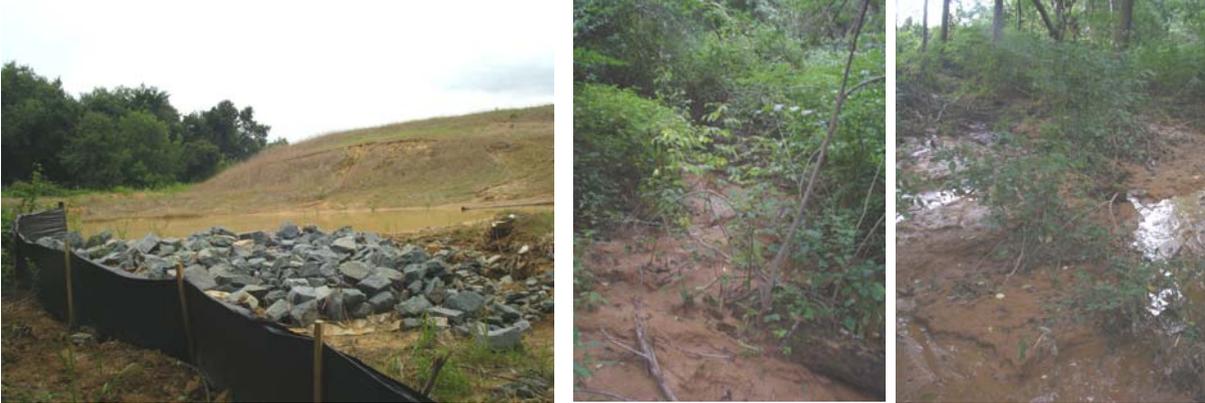
Figure 5. Sediment Pond and Downstream Sediment Deposition at Reach A1-2

The need for ongoing enforcement of the erosion and sediment control regulations is evidenced by this site in the A1 subwatershed (Figure 5). Though the site has ESC controls installed, they have not been properly maintained. The downstream tributary (Reach A1-2) is covered with 2-3 feet of sediment and does not have a defined stream channel. As this site is developed and the pond is eventually converted to a stormwater facility, more stringent inspection and enforcement should be implemented.

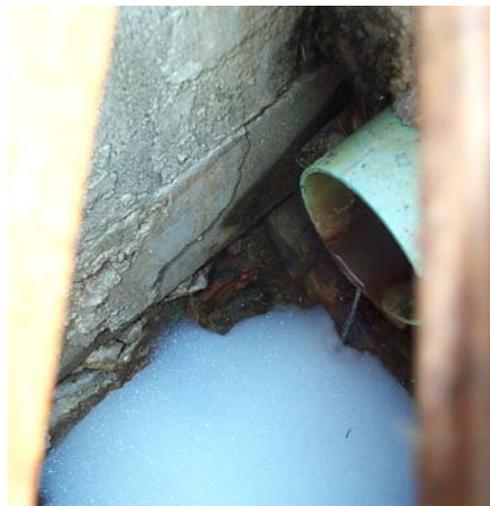
Figure 6. Suds discharging to the storm drain at the State Police station in Odessa

Figure 6 shows an illicit discharge to the storm drain system witnessed by CWP at state police headquarters in Odessa. The car washing bay appears at this site to be connected to the storm drain rather than to the sanitary system. Simple diversion of this runoff to a landscape feature as part of a larger retrofit project would be appropriate.

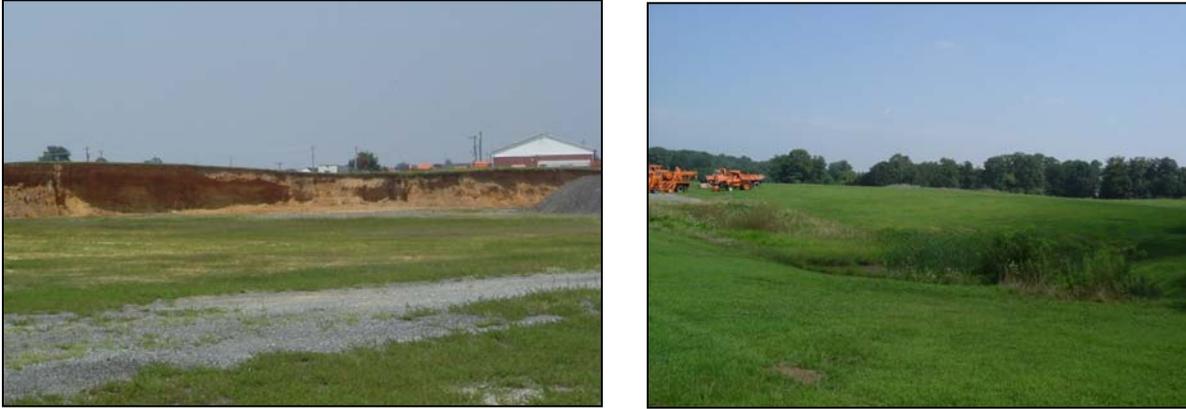
Figure 8. DelDOT (DP-HS-6) fill dirt removal area (left) and existing stormwater facility (right).

The stream reach (RCH-0) draining from this site was in good condition with the exception of a headcut (ER-2) below the yard's stormwater outfall (OT-1) and some historic trash dumping (TR-1 and TR-2). Structural recommendations for the DelDOT yard include retrofit (DP-1) of the existing pond to provide channel protection; covering the salt truck loading area; providing water quality treatment for the runoff from the salt barn area; stabilizing eroding channel. Also, the existing pollution prevention plan for the facility should be reviewed. This retrofit provides a good opportunity to work with DelDOT on a high priority project.

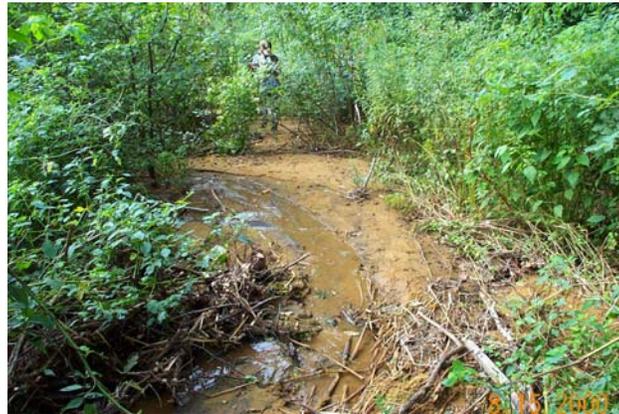
This short first order tributary to Deep Creek is in poor condition with evidence of extensive sediment deposition throughout the floodplain and lower portions of the reach and severe areas of active bank erosion (6 foot banks in some locations) and (Figures 9 and 10, respectively). Much of this damage was likely done during the construction phase of development, however the channel is still actively adjusting. After investigation of upstream stormwater practice, it seems that the restoration option here is to stabilize the headcut and safely convey stormwater discharges from the outfall to the stream (Figure 11). NCC should inspect the stormwater facility during and after a rain event to make sure it is functioning properly.

Figure 9. Extensive sediment deposition in floodplain

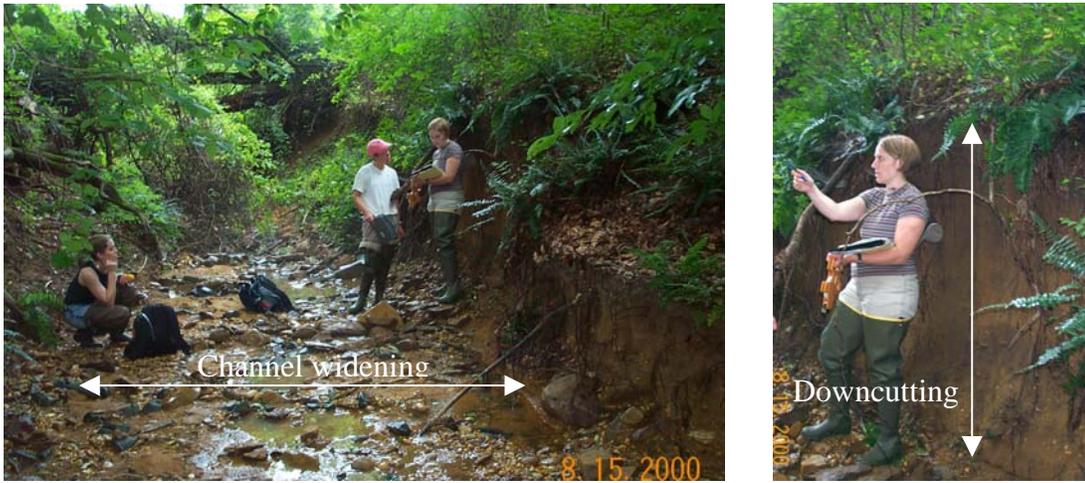
Figure 10. Evidence of significant channel erosion (widening and downcutting) as result of headcut to Cricklewood outfall.

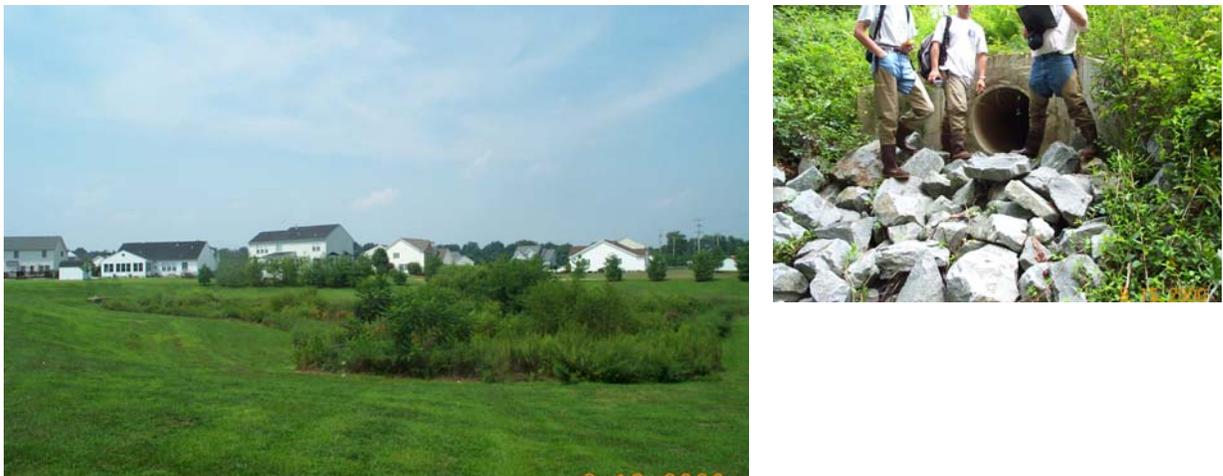
Figure 11. Outfall to stream from dry pond at Cricklewood neighborhood.

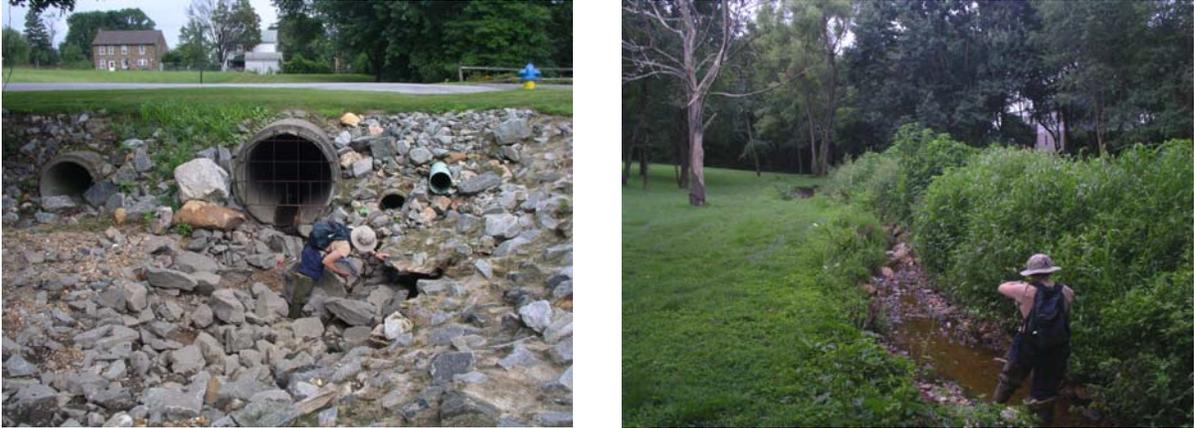
Figure 12. Outfall draining to Reach DP-20 and un-buffered stream corridor.

Four outfalls at the intersection of Park Street and Cox Street in the Town of Middletown (Figure 12) constitute the drainage for 57.5 acres of residential and commercial land, including the runoff from DE-71 (Broad Street). This project should be pursued with DelDOT, as it combines stormwater retrofit and stream restoration: a stormwater treatment practice on the vacant lots across Cox Street (DP-8), a replanted buffer (IB-1), and stream repair/culvert replacement (SC-1).

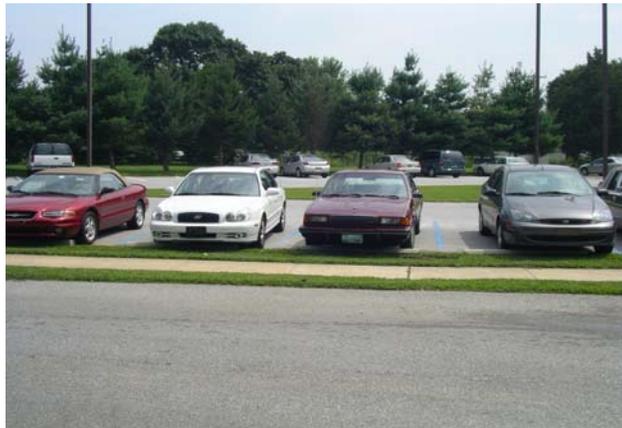
The MOT Senior Center parking lot presents an opportunity for volunteer-created rain gardens (Figure 13). Additionally, the existing dry pond should be retrofitted to include a micropool, defined low flow channels, and wetland plantings. Rain gardens in the parking lot and at building downspouts.

Figure 13. MOT Senior Center parking lot, a proposed rain garden site.

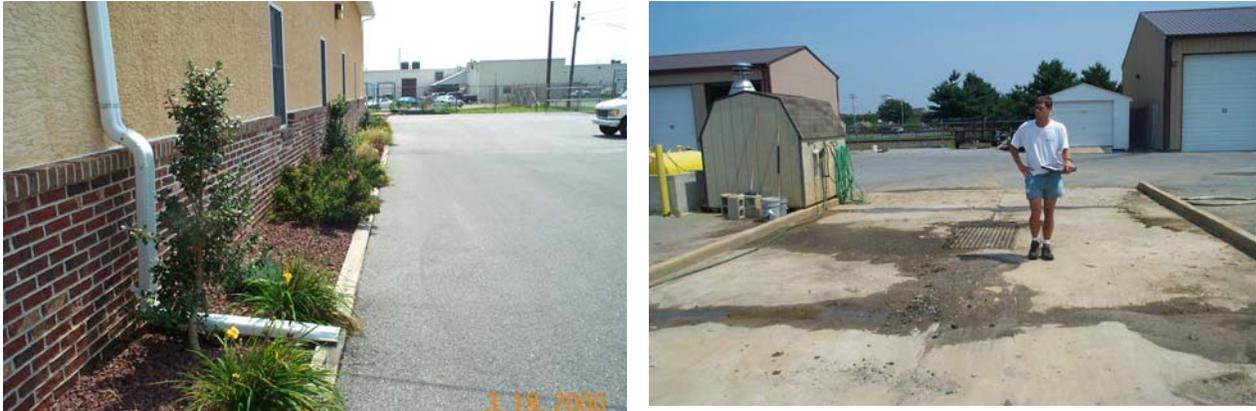
Pending further drainage investigation, this site may drop off the priority list for implementation of source control practices. CWP observed many good housekeeping practices at this site, including covered storage and secondary containment, however it is unclear if the vehicle washing area drains to a treatment practice. In addition, this is an excellent opportunity to demonstrate downspout disconnection efforts, such as the installation of rainbarrels (Figure 14). Fueling for Department vehicles is done off-site.

Figure 14. Opportunity for rain barrel demonstration (left) and drain at washing station (right)

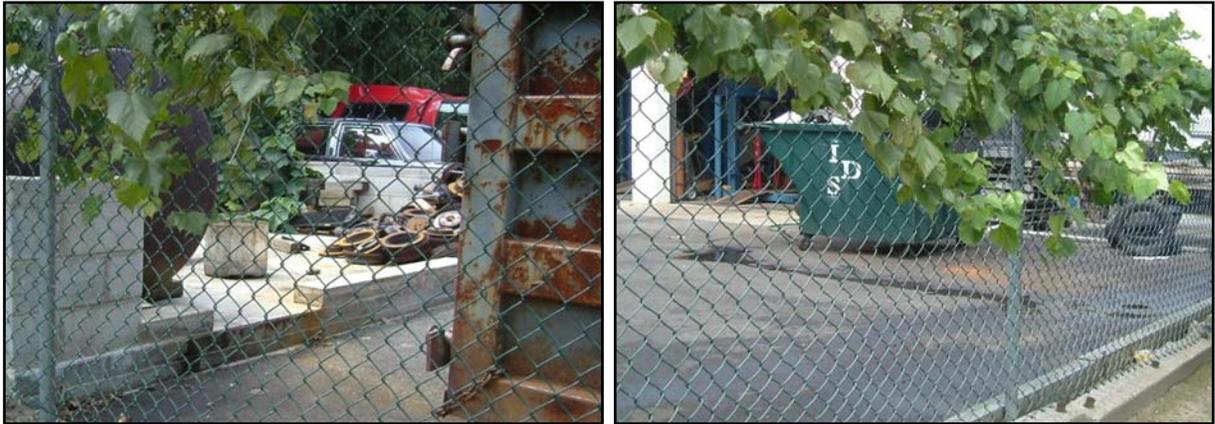
Meineke (HS-9), was a confirmed hotspot as gas and oil were stored without secondary containment on concrete and asphalt areas, and evidence of leakage was found (Figure 15). ARA should conduct dumpster and outdoor storage education with this business to educate them on how to properly store hazardous wastes such as gas and oil. Happy Harry's (HS-3) is another example of poor dumpster management in commercial areas. Figure 16 shows how Happy Harry's rusting dumpster is oriented in close proximity to the storm drain. Dumpster education is important here, but the solution could be as simple as the owner moving the dumpster up onto the grassy area, which would probably best be accomplished by installing a gravel trench on the grass under the dumpster.

Figure 15. Poor outdoor storage and waste management found at the Meineke location on Main Street in Middletown (site DP-HS-9).

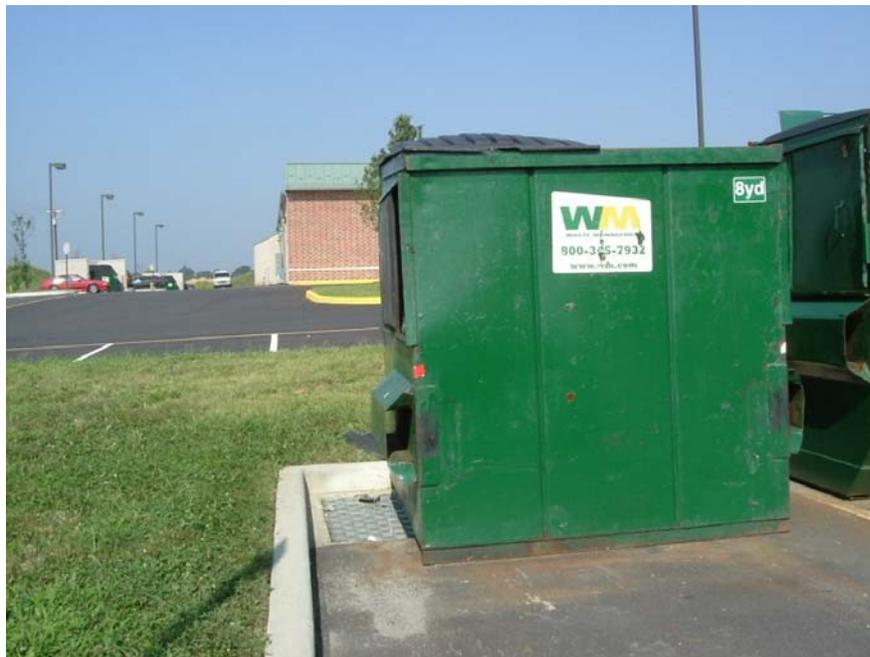
Figure 16. Rusting dumpster located on top of the storm drain inlet at Happy Harry's on Main Street in Middletown (HS-3).

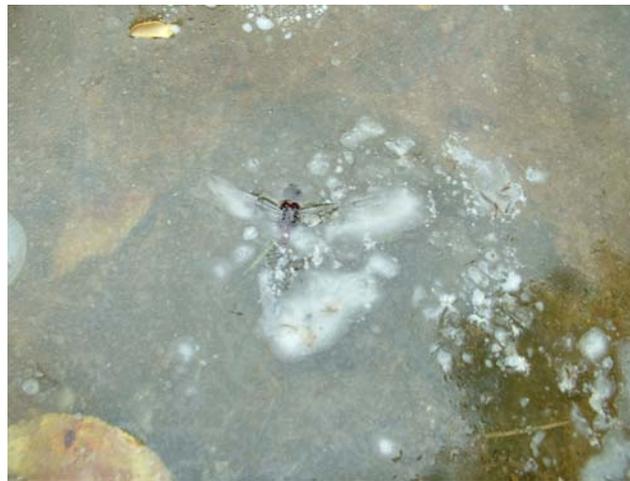
OT-6 is another site where an illicit discharge had occurred at a 54-inch outfall located between Hayley Court and Weston Drive. When CWP staff and a DNREC biologist visited the site, some form of toxic event was occurring in the pool below the outfall. There were dead insects in a white viscous liquid, possibly paint or paint thinner, that formed a film with thick oily globs of the unknown substance (Figure 18). The outfall pool, which likely would have been inhabited by amphibians and possibly small fish, appeared to be lifeless. The recommendation is to initiate monitoring and utilize neighbors to assist in keeping an eye out for suspicious conditions. Mapping the drainage pipe network to the outfall is also critical to determine where the discharge may be originating – perhaps even initiating dye testing of businesses to determine possible sources of illicit discharges in the catchment. This is the highest priority illicit discharge found in this subwatershed due to the presence of toxicity in the pool.

Figure 18. Illicit discharge and dead insects in OT-6 outfall pool

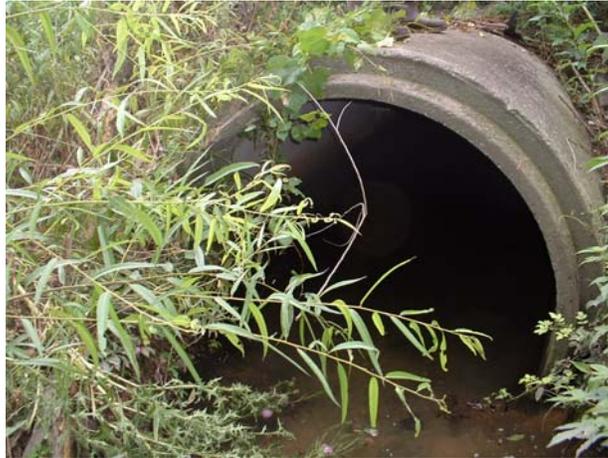
Figure 19. OT-8 outfall

OT-8 is a site with potential illicit discharges located along North Broad Street near the intersection with Rt. 301 (Figure 19). Potential illicit discharges could be occurring based on the presence of oil sheens in the pool below the outfall. Commercial land uses in the drainage to the outfall includes: Schagrin gas, Southern States, a Citgo gas station, and a portion of Johnson Controls. The drainage to this outfall should be investigated further as it falls in the upper portion of the watershed and any impairment here may affect downstream waters.

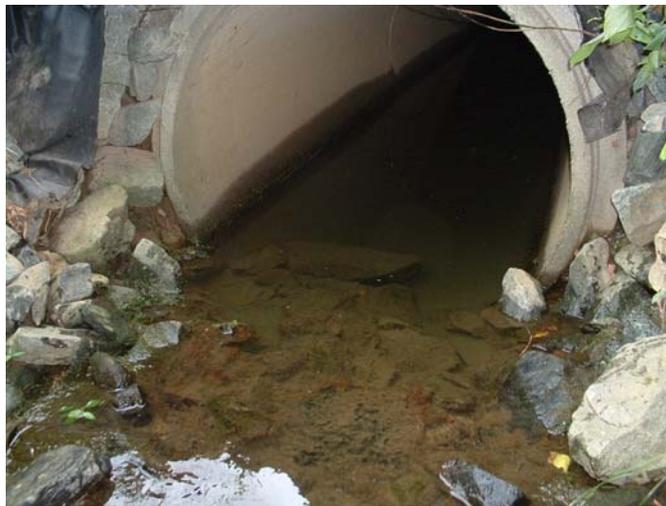
Figure 20. OT-7 outfall with decaying algae on stream bottom

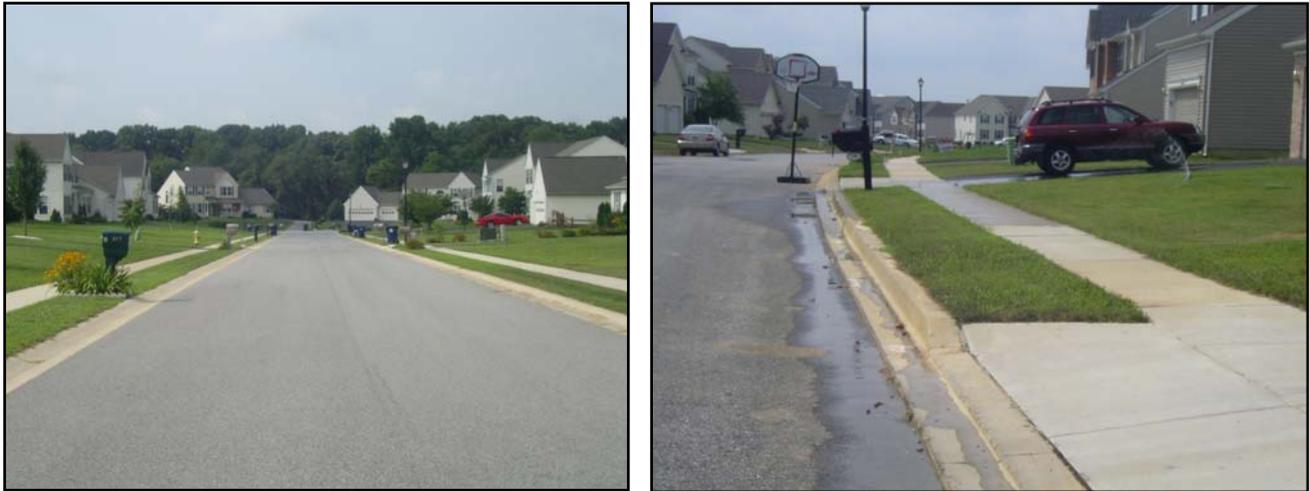
Figure 21. Well-manicured, high input lawns (left) often result in runoff of excess fertilizers and pesticides, especially when non-target irrigation occurs.

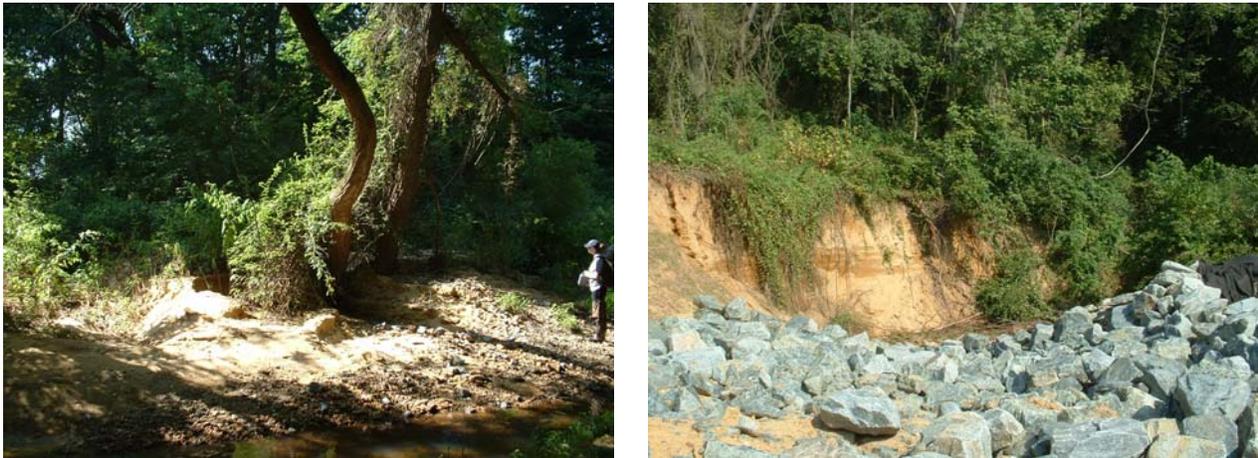
Figure 22. (Left) Location where the small drainage channel outlets to the stream; note: several feet of sediment aggradation to the right and center of the picture. (Right) Water is conveyed into a steep highly eroding slope with no toe protection.

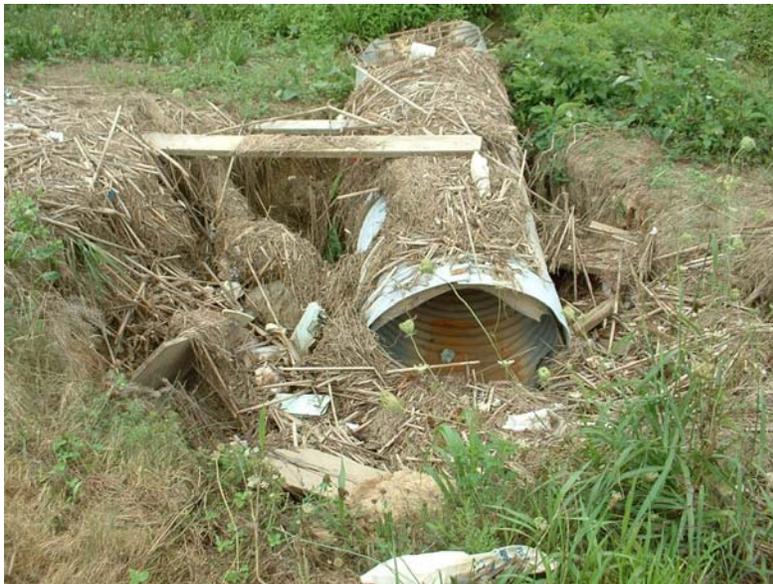
Figure 23. Failing pond outlet (ER-5) near Brady Circle

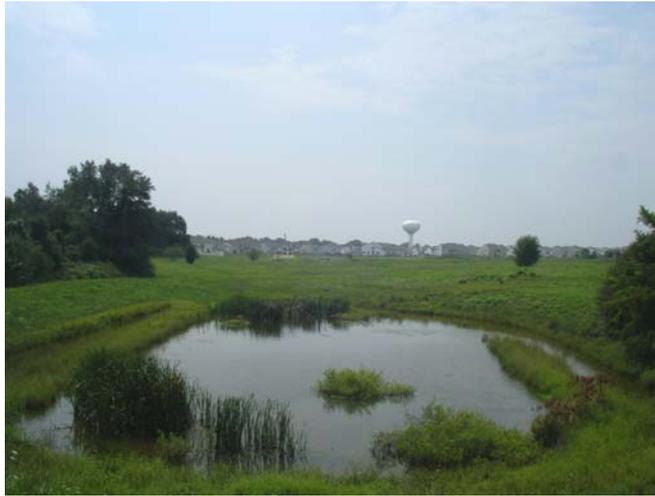
Figure 24. Existing Greenlawn pond and open area (DV-2)

The 230-acre Greenlawn subdivision and associated multi-family housing and commercial development drain to the stormwater pond shown in Figure 24. As this development was the last to be approved under old stormwater regulations, this facility does not provide significant water quality benefits. The old sediment basin(s) should be converted to shallow marsh wetlands, and the pond riser should be replaced with a concrete riser that is designed with water quality and channel protection control (DV-2).

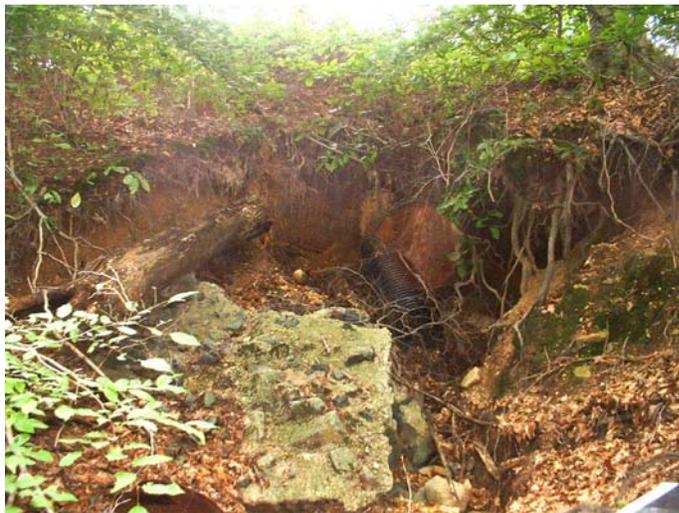
Figure 25. Erosion and failed conveyance from stormwater from adjacent neighborhood

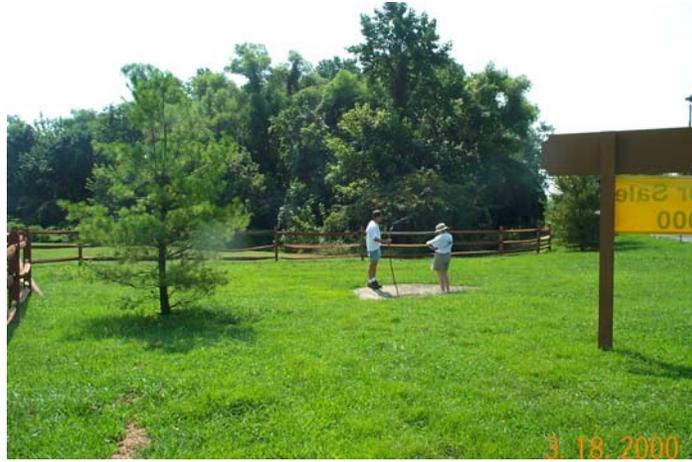
Figure 26. Inlet at Villagebrook entrance, a proposed bioretention site (DV-3)

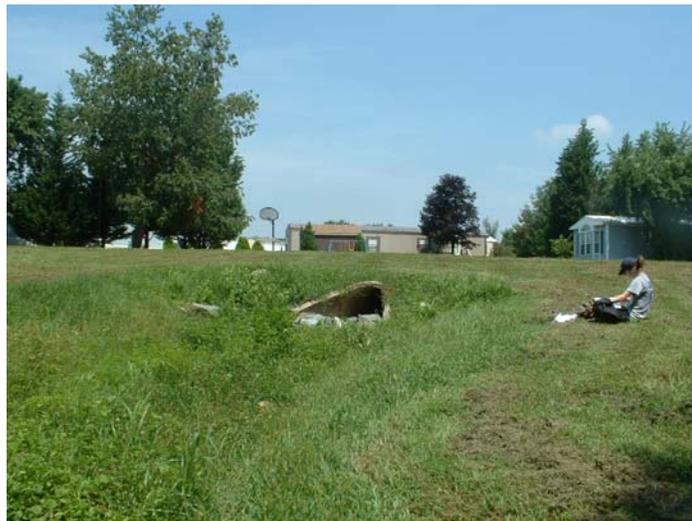
Figure 27. Outfall in Villagebrook (DV-4)

At an outfall location currently under retrofit design by DNREC, flow from the outfall currently traverses a grassy area before crossing a slope into a small wetland complex (Figure 27). The retrofit concept (DV-4) here is to convert the grassy area into a peat filter, and incorporate a level spreader and rock step pools into the design to convey discharges safely across slopes.

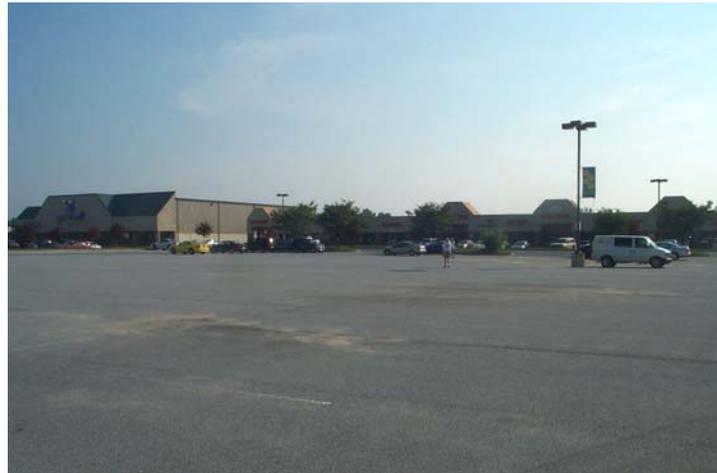
Figure 28. Middletown Square Shopping Center (DV-5)

This shopping center, currently anchored by Goodwill, drains to the Greenlawn pond described as retrofit DV-2 (Figure 28). However, water quality benefits can be provided in this parking lot through the use of linear bioretention between parking aisles. Trees used in the bioretention could provide canopy cover for the parking lot.

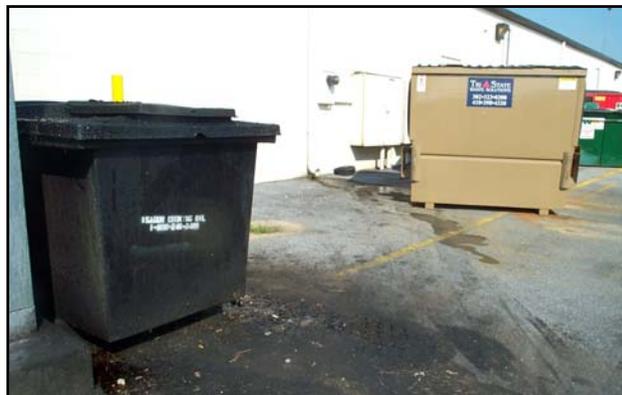
Figure 29. Poor waste management was evident at the Middletown Square shopping center, including this oil storage container with obvious and continual leaks.

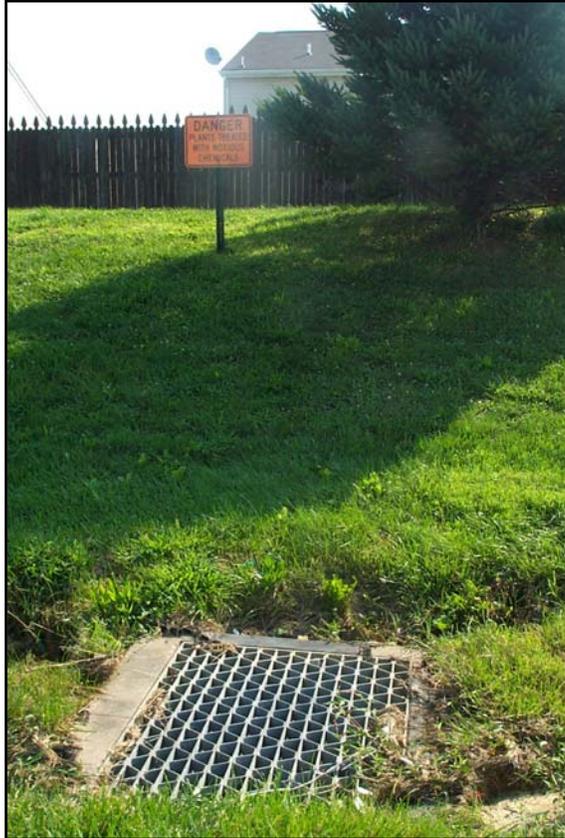
Figure 30. This storm drain, located behind the Middletown Square shopping center, should be a priority to prevent “noxious chemicals” from entering it.

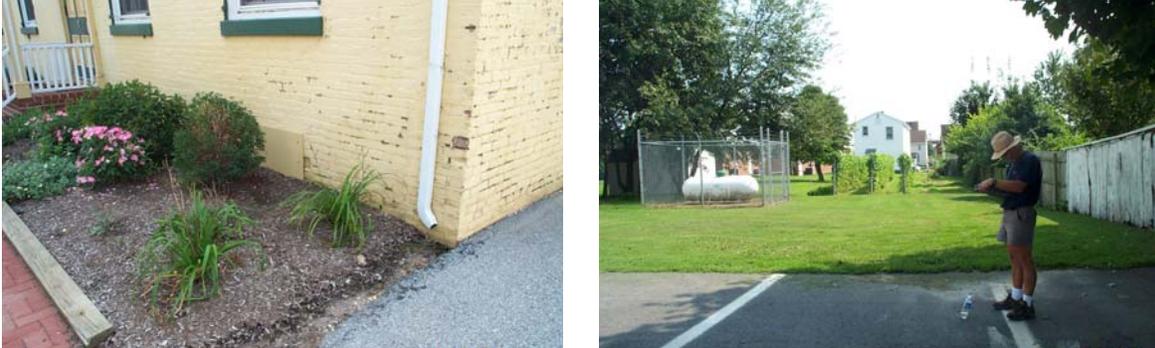
Figure 31. Downspouts direct untreated rooftop runoff through the parking lot and into storm drains. This turf area can be used to treat parking lot runoff.

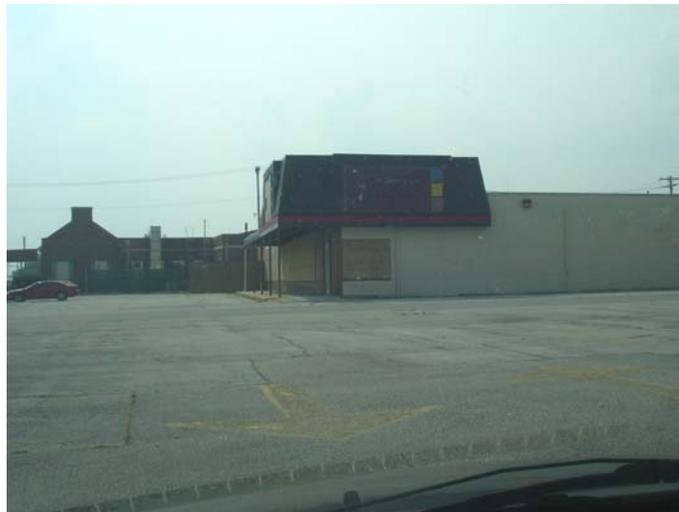
Figure 32. Old Acme, location of new Town Hall (DP-28)

addition, ARA should actively encourage the local government to incorporate these types of practices into designs for the new town hall building, which is will be located at the old Acme grocery store downtown (figure 32).

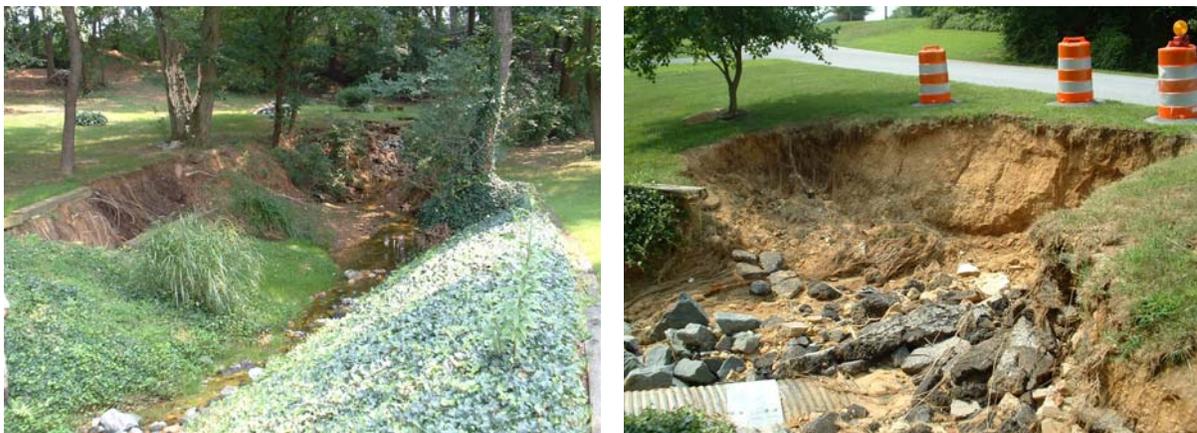
Figure 34. (Left) View of the outfall erosion; note: water is likely running off from adjacent street and contributing to the problem. (Right) Stream bank erosion.

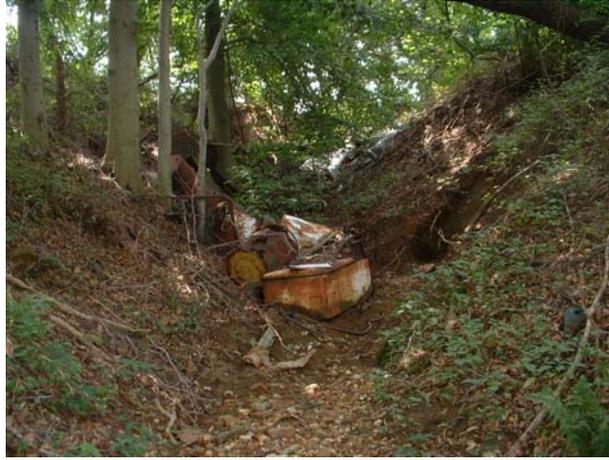
Figure 36. Typical trash dumping site in a ravine in Drawyer Creek

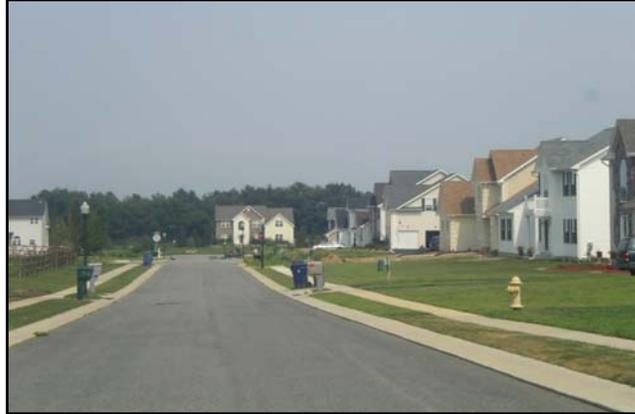
Figure 39. Neighborhoods in Hangman's Run featured high or medium input lawns.

Four neighborhoods in Hangman's Run were assessed, and two of these showed signs of high turf management including the use of fertilizers and pesticides (Figure 39). Primary education objectives for this subwatershed include turf management and promoting the use of rain gardens and rain barrels. Priority neighborhoods to target are Cantwell Ridge and Bishops Walk due to channel erosion and associated impacts downstream of these neighborhoods.

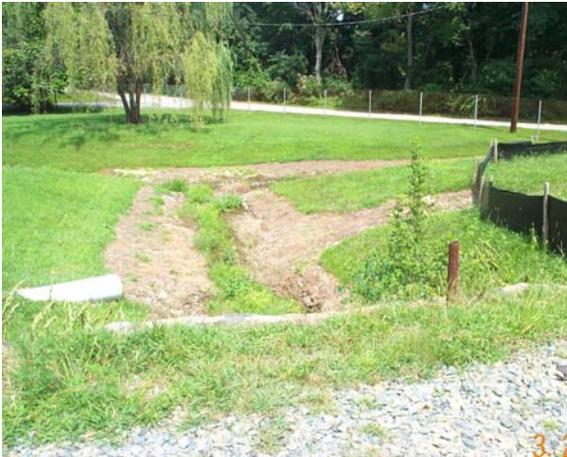
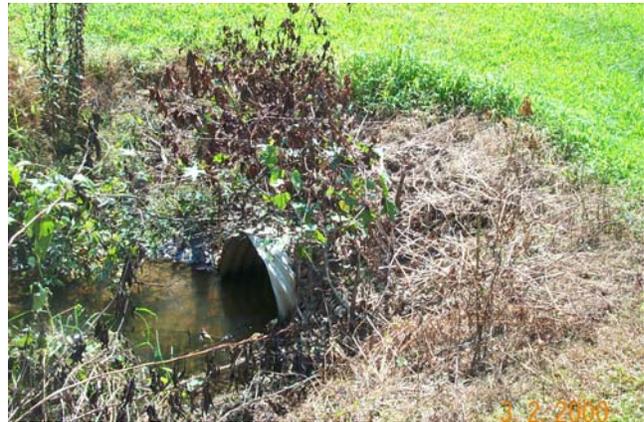
Figure 41. Evidence of spraying and mowing along “tax ditch” at RCH4/5 (left) and RCH-6 (right)

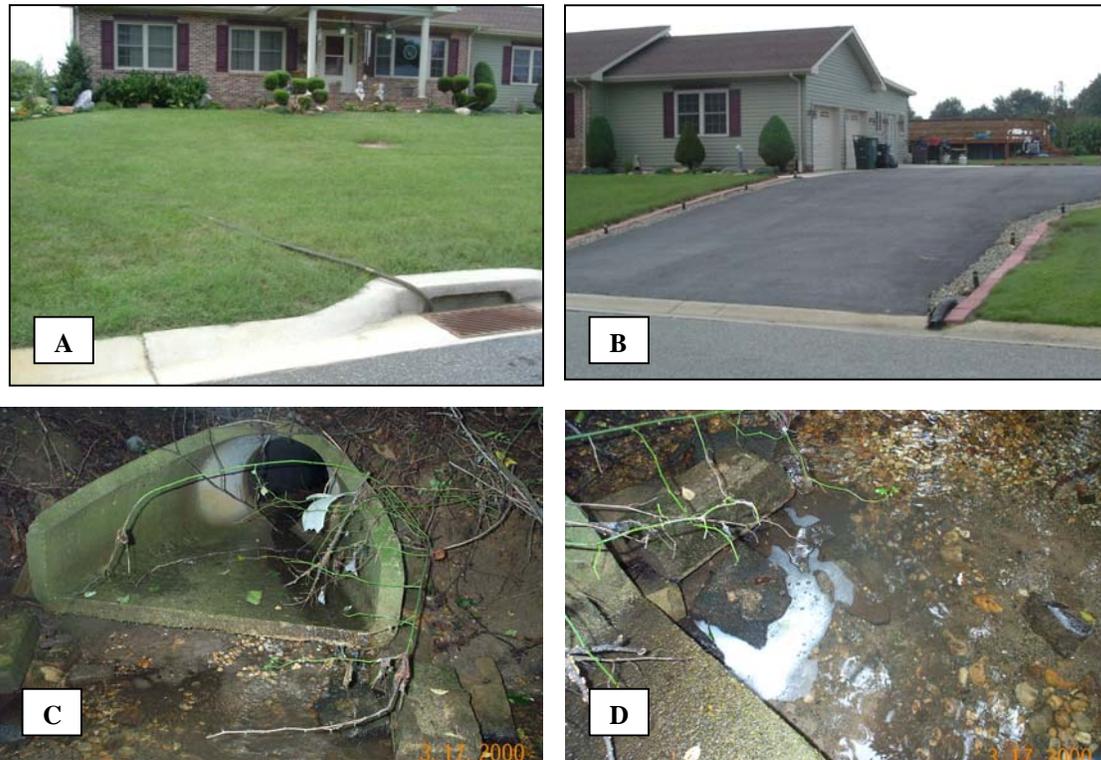
Figure 43: (a) Hose leading directly into storm drain with unknown source; (b) downspouts directly connected to street; (c) outfall end section supported by bricks with dry weather flow; (d) suds from dry weather flow.

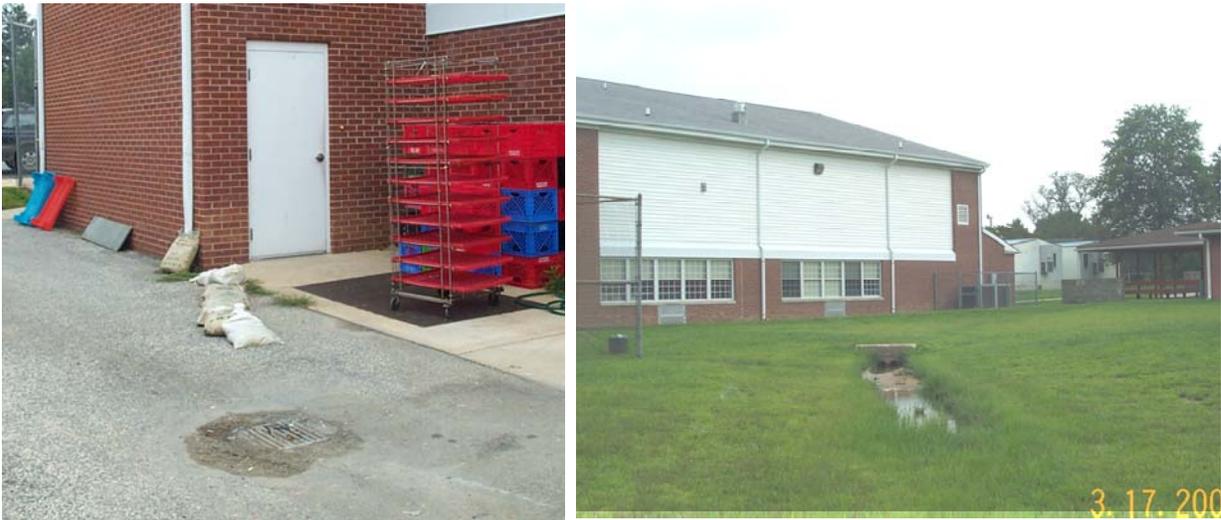
Figure 43. Clogged drain and evidence of flooding issues at loading area for Townsend Elementary (on left). Twin 6” outfalls in back of school in retrofit area (on right).

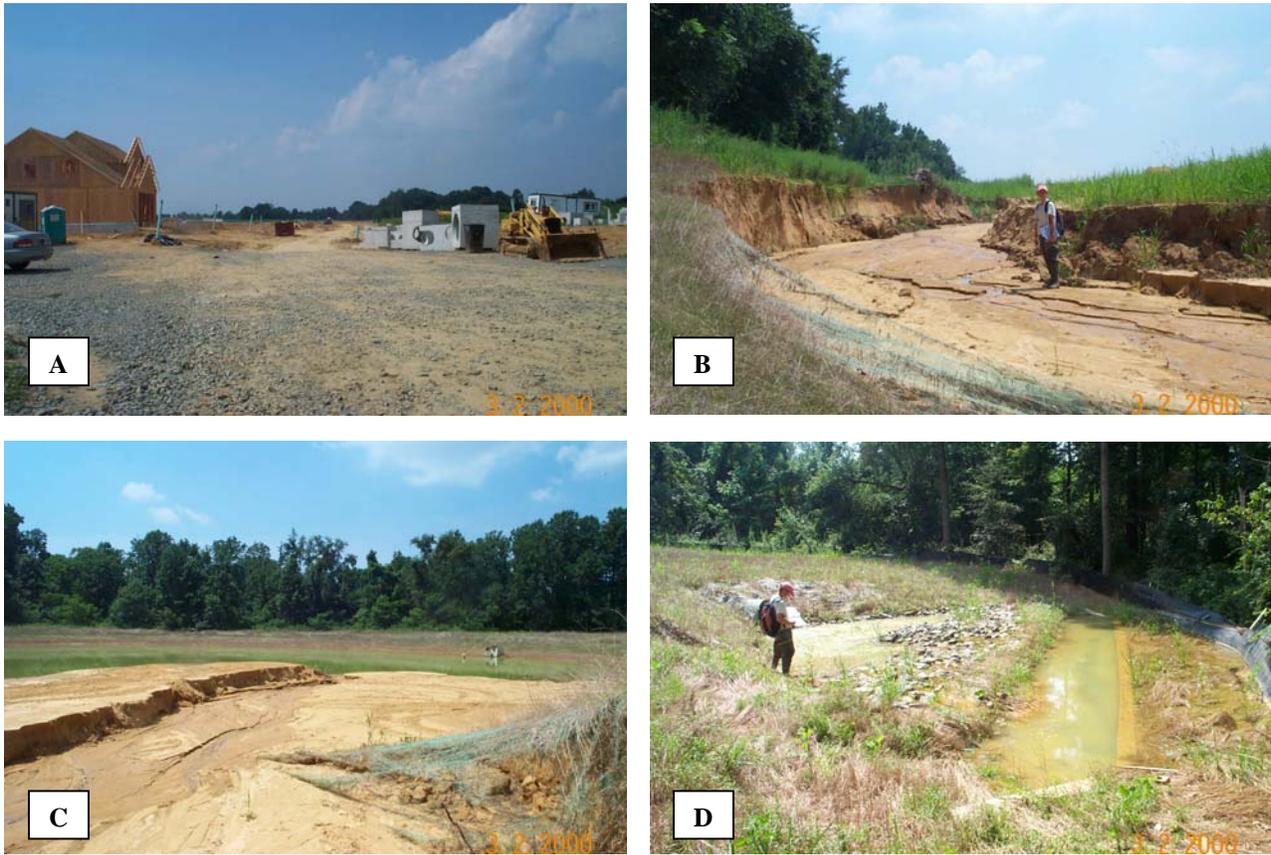
Figure 44. (A) Rock pad at entrance to construction site; (B) gully formed from surface runoff to sediment pond (see reinforcement matting in foreground); (C) view of large sediment basin; (D) outfall structure (see downstream silt fencing).

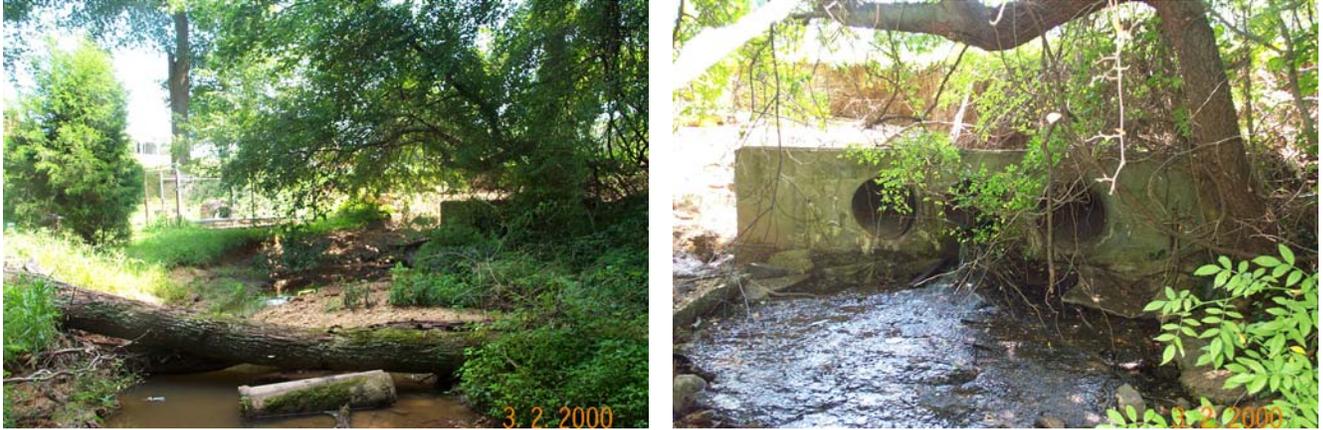
Figure 45. (Left) RCH-3 looking upstream towards farm pond. Note lack of buffer, sediment bars, and stream bank erosion. (Right) Shows outfall from farm pond with eroded embankment in the background.

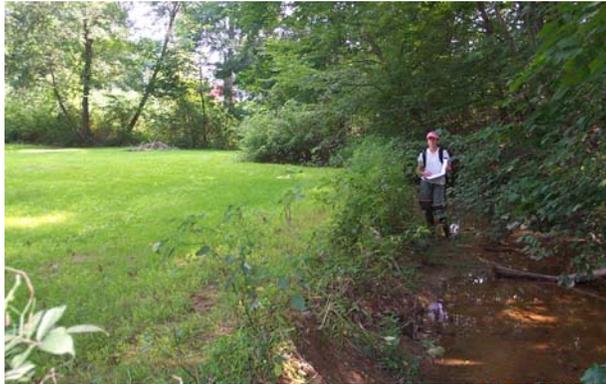
Figure 46. Buffer continues to be impacted further downstream along RCH-3

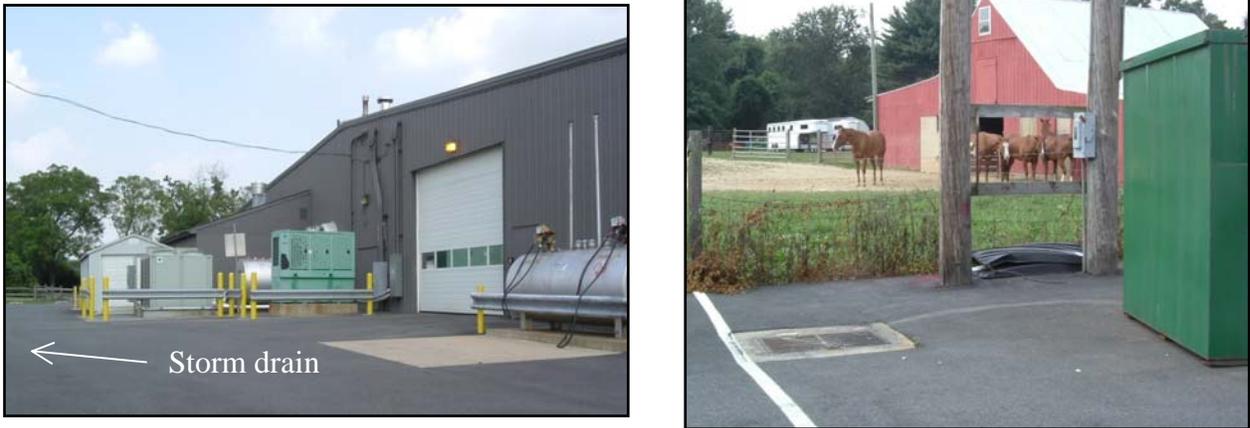
Figure 47. An outdoor fueling area (left) and dumpsters (right) are located too close to the storm drain without runoff diversion methods. A bermed facility around both of these storage areas may prevent polluted water from entering the storm drain.

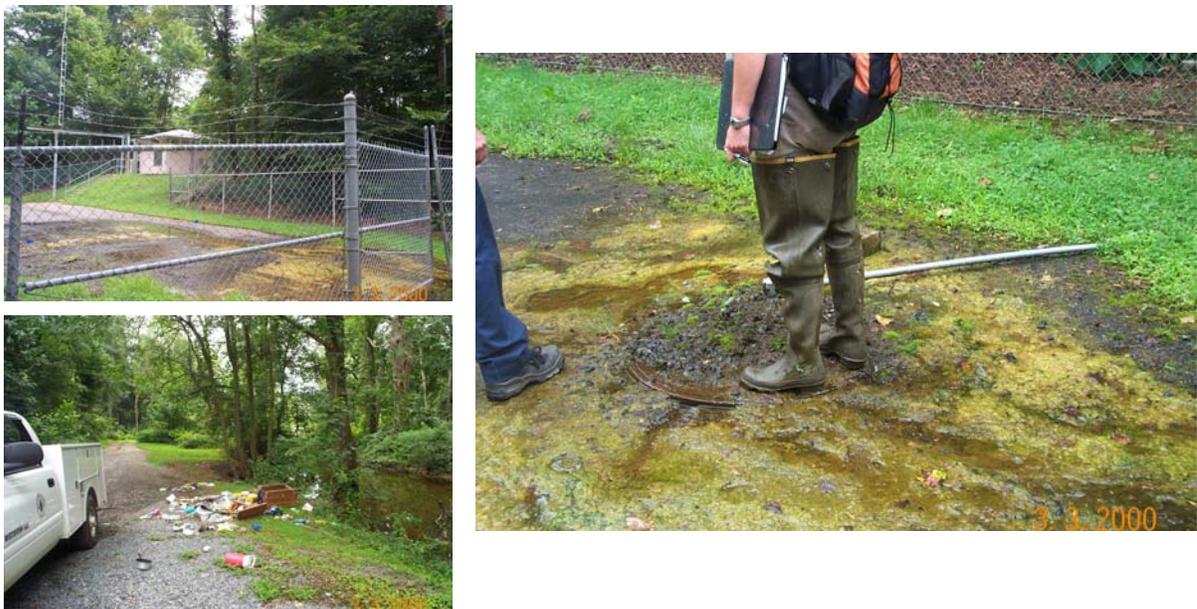
Figure 48. (A) Pump station and algal mat across parking lot. (B) Close up of algal mat and manhole cover. (C) Trash dumping.

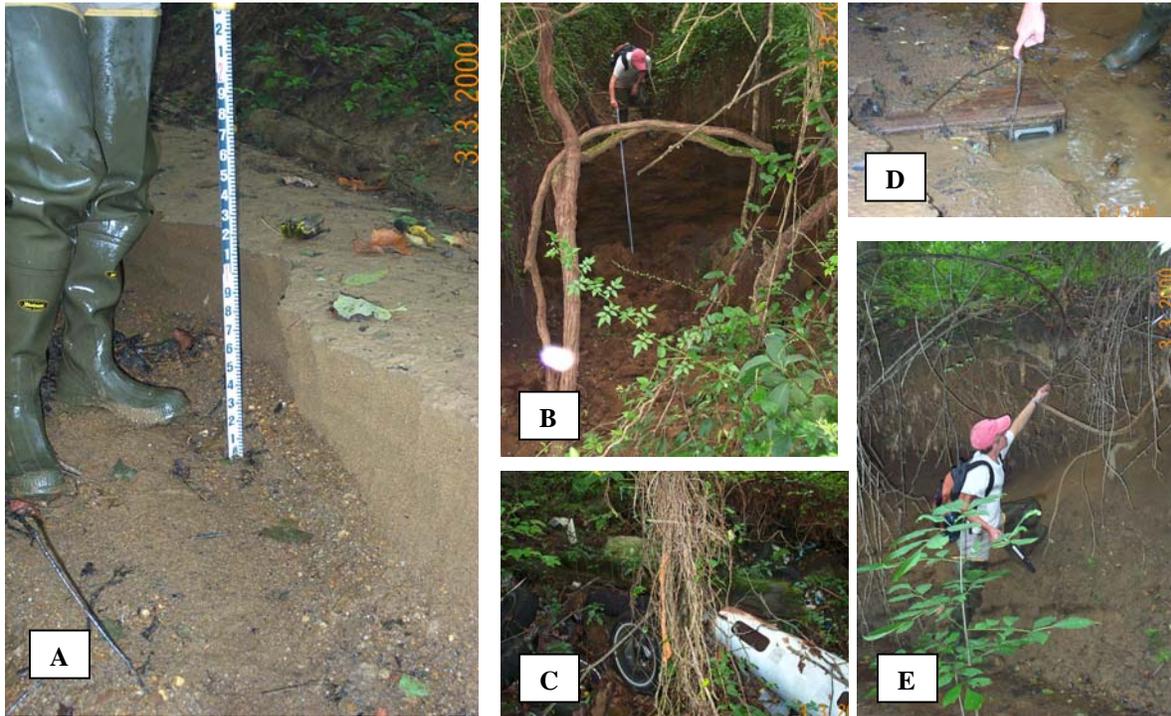
Figure 49. (A) shows almost a foot of sediment rapidly transported through channel; (B) 5-6 ft head cut; (C) trash and debris along stream bank; (D) standard television buried in middle of stream channel; (E) actively eroding (widening) stream channel
